Manhole Inspection Summary

Manhole # S45MM_041MH

Insp Date: **3/25/08 10:24 AM**

Location Address: **20th**

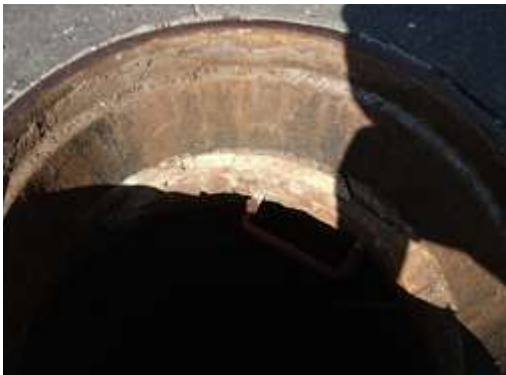
Defect 1

Condition: ☐ Sound ☐ Cracked ☐ Root Intrusion ☒ **Loose Brick** ☐ Deteriorated

Adjustment Joint

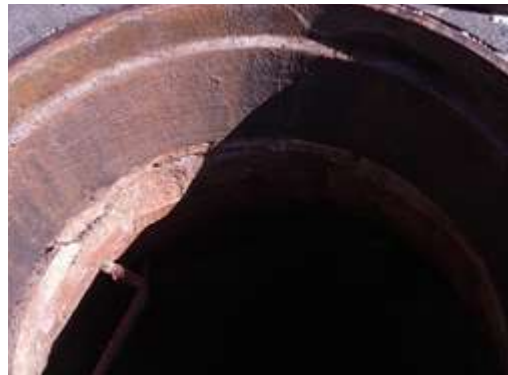
Defect 2

☒ **Leaks**

Frame Leaks

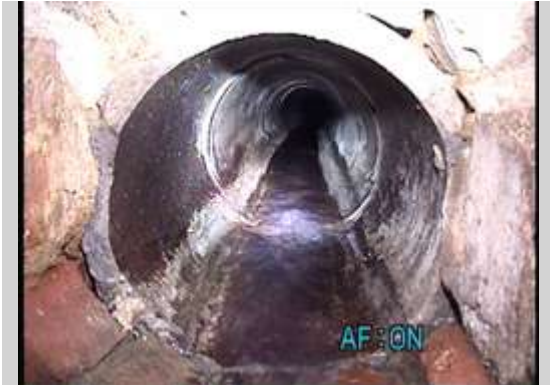
12 O'Clock Outflow

8 in. Circular Gravity Sewer
Pipe Out @ 12 O'Clock

Pipe Height: **8.4** (in.) Rod and Bar (Angled)
Pipe Material: **Clay** ☐ Pipe Lined
Invert Depth: **6.60** (ft.) Flow Characteristics: **Slow**
Deposits: ☒ None ☐ Mud ☐ Sludge ☐ **Debris** ☐ Grease
Silt Depth: (in.) Deposits Extent:
Infiltration: **None** Pipe Seal Cond: **Sound**

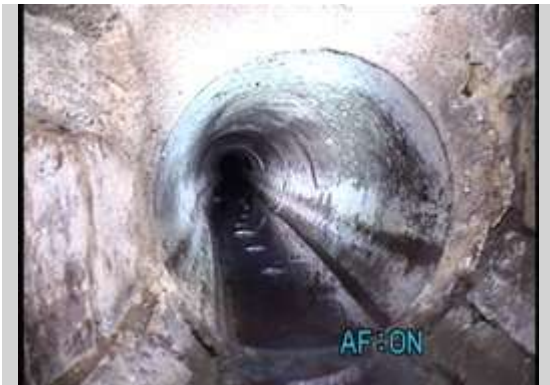
3 O'Clock Inflow

8 in. Circular Gravity Sewer
Pipe In @ 3 O'Clock

Pipe Height: **8.4** (in.) Rod and Bar (Angled)
Pipe Material: **Clay** ☐ Pipe Lined
Invert Depth: **6.50** (ft.) Flow Characteristics: **Slow**
Deposits: ☒ None ☐ Mud ☐ Sludge ☐ **Debris** ☐ Grease
Silt Depth: (in.) Deposits Extent:
Infiltration: **None** Pipe Seal Cond: **Sound**

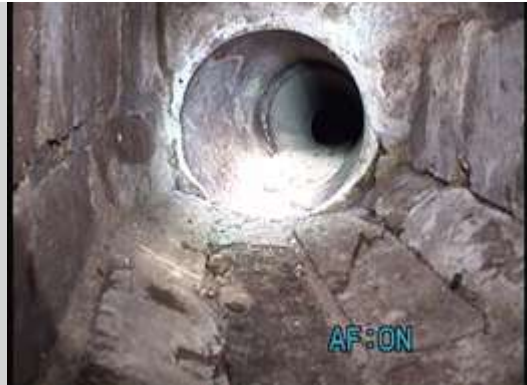
8 O'Clock Inflow

Deposits: ☐ None ☐ Mud ☐ Sludge ☒ **Debris** ☐ Grease

Silt Depth: **1** (in.) Deposits Extent: **Light**
